ANALYSIS OF THE CAUSES OF FAILURE OF A STOREY BUILDING ALONG OSUN STATE UNIVERSITY ROAD, OSOGBO.

Olawale, Simon O. A

Department of Civil Engineering, Osun State University, Osogbo, Nigeria.
olawales@hotmail.com

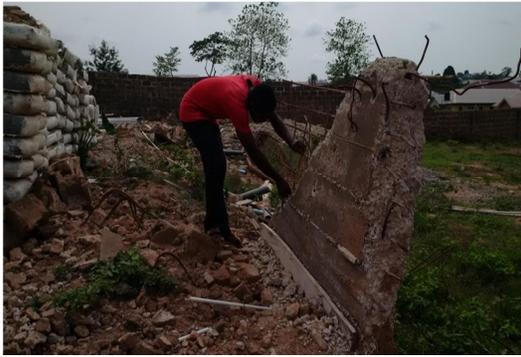
Figure 2: Remnant of the Collapsed Building on the Site along University Road, Osogbo.
