## THE DEFECTS IN THATCHED RHOMBU GRAIN STORAGE SYSTEMS IN SUDAN SAVANNAH OF NIGERIA

The objective of this study is to evaluate the defects that exist in the thatched rhombus system of grain storage with the view to analyse it appropriateness for use as a grain storage system.

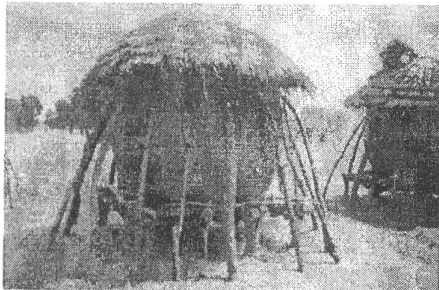
Plate 1a: Tree stem foundation assembly with supporting poles

The foundation – floor assembly is usually made of irregular stones and tree stems or tree poles stems penetrating the ground, and crossed with other tree stems. The defect includes low elevation which ranges between 100mm to 600mm with no rodent guard except for very few rhombus which has thorns used as rodent guard. The low elevation is basically to ease loading and unloading of the grains. In raining season however, water still splash on the walls and seeps into the structure due to the low elevation; which leads to moisture absorption by the stored grains. The main cause of this defect is the inadequate design of the structure adopted by the farmer and the poor strength of material (Plate 2).
